Roland Avenue Stream Rehabilitation

project description | stream restoration

Lexington, Kentucky

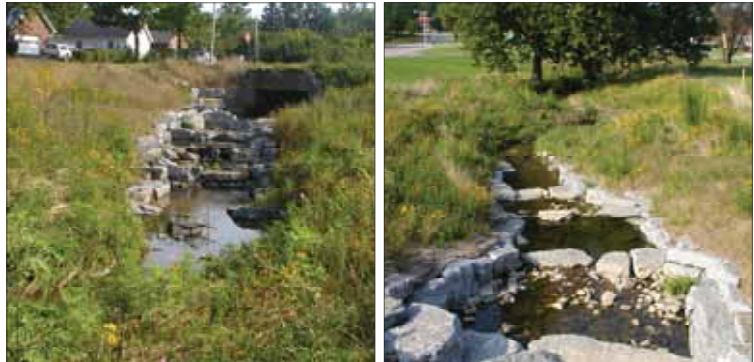
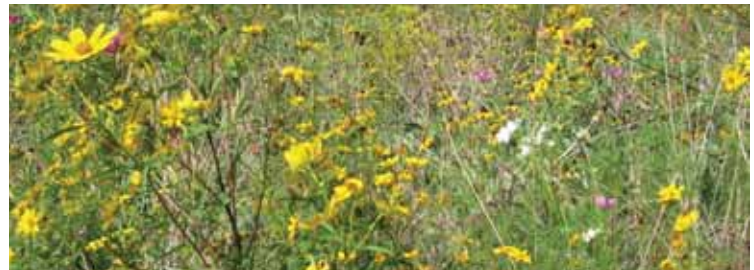
background: The stream that flows through the LFUCG property along Eastland Parkway was undergoing severe bank and bed erosion. The straightened and entrenched channel lacked stable bank slopes and appropriate riparian vegetation as well as vertical stability.

solution: The design consisted of stabilizing 400 l.f. of the stream by laying back the steep banks, installing a step pool system, a new headwall, a rock vane and rock toe, and establishing natural vegetation. By laying back the banks, a more appropriate angle was established for bank stability and the stream gained floodplain access. The step pool system was installed directly downstream of a box culvert, which marked the upstream end of the project and revealed poor vertical stability of the stream reach. The step pool system enhances stream habitat, provides stream aeration, allows fish migration, and provides vertical and overall stream stability (preventing further bed cutting and resultant bank erosion). The rock vane that was installed reduces the local erosional forces along the stream bank and around the new headwall. A rock toe was installed around one bend to reduce the erosion of the toe of the bank. Finally, the natural vegetation provides additional stability to all aspects of the project as well as enhance the stream ecosystem and aesthetics.
