## Brushy Creek Stream Restoration Project

project description | stream restoration

Greenup County, Kentucky

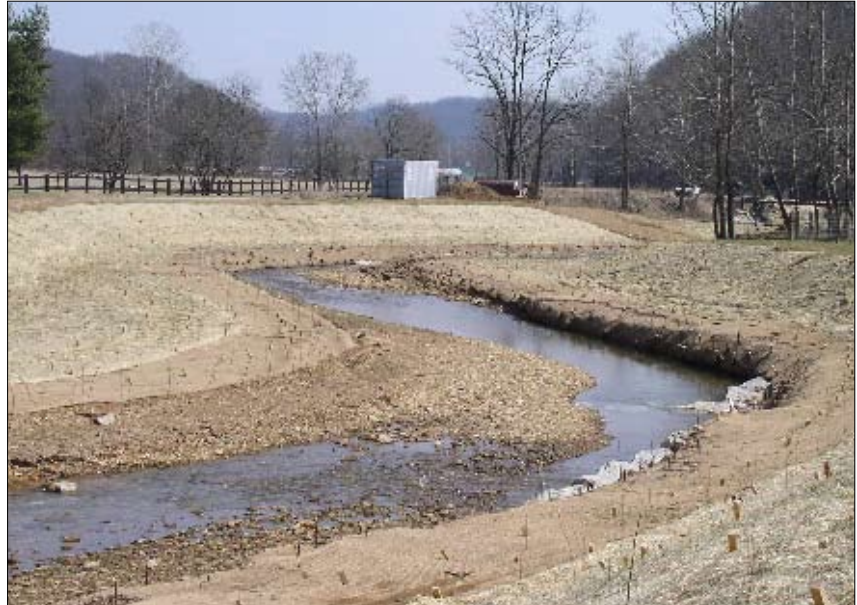
*Restored Photo*

**solution:** Brushy Creek was restored to a stable C4/B4 stream with proper bankfull dimensions based on the design. By returning it to a stable plan form, profile, and cross-section the stream was stabilized and protected from further erosion, enhanced aquatic habitat by constructing stable riffles and pools, and improved water quality. Habitat was created by the installed rock structures, deep scour pools, and willows, alder and other tree species planted along the stream edge that, overtime, will grow their own root system along the bank. Water quality will be improved by greatly reducing the amount of sediment that was eroding from the unstable banks and fencing out livestock from the stream to reduce the fecal coliforms. A riparian buffer of native trees and shrub were planted to provide habitat and shade to reduce the water temperatures.
